## Offshore Oil Rig Protects its People and Equipment Using the ALL-TEST PRO 5™

*Authors: Aaron Schnelle, Technical Support, and Shane Franklin, Regional Manager, ALL-TEST Pro LLC*

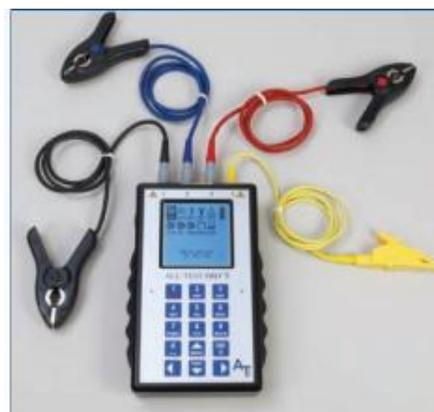
they had been in talks with Shane Franklin from ALL-TEST Pro about the ALL-TEST PRO 5™, a hand-held motor circuit analyzer. They decided it would be the perfect piece of test equipment to help them confirm their suspicions.

Instead of purchasing the AT5™, the electrical supervisor decided to rent the AT5™ de-energized motor testing instrument from Intellirent, a DFW area-based company that rents out a variety of electrical test equipment across the United States. Within 48 hours, Intellirent had the AT5™ delivered out to the
